RE: Site Inspection, DOE/O19/029, Judy No. 1 & 2

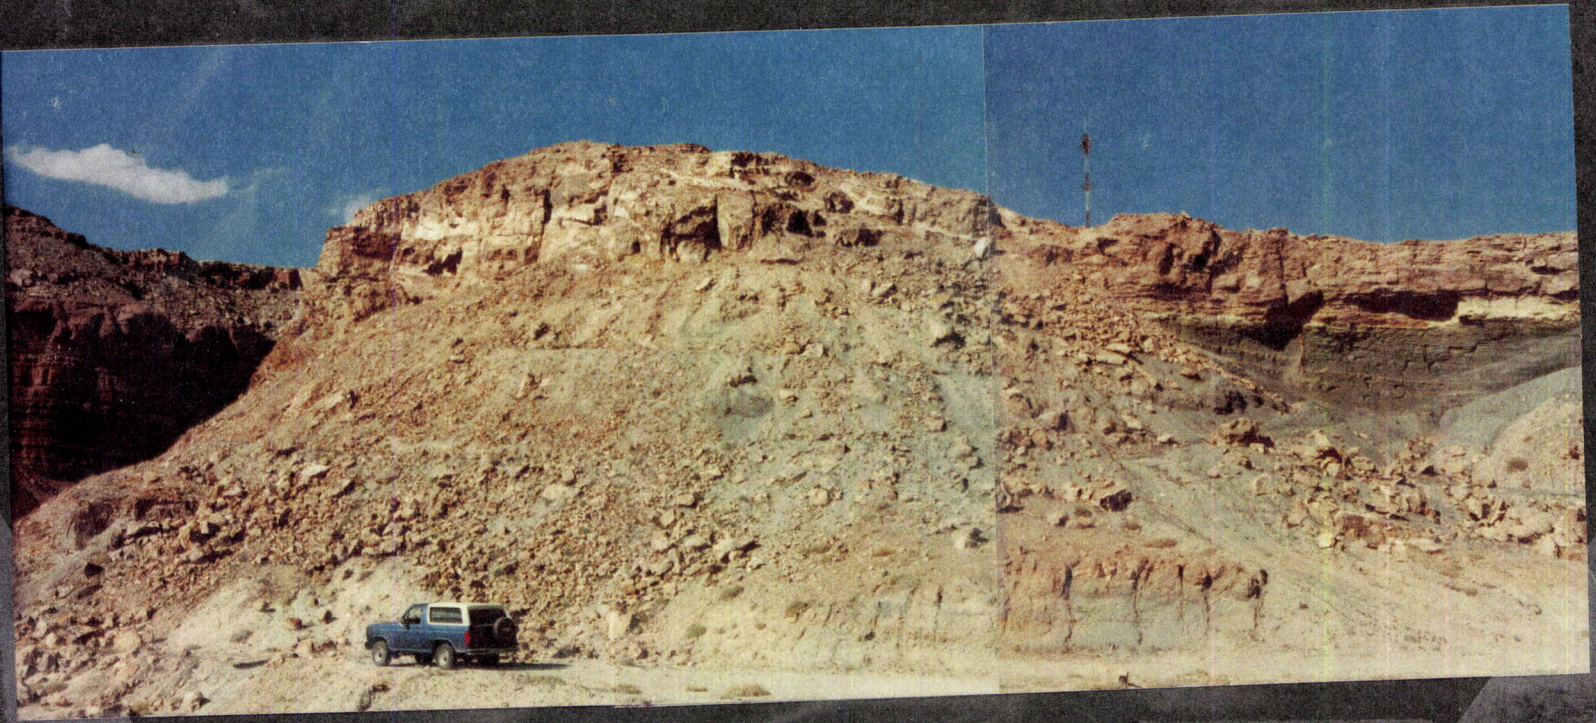
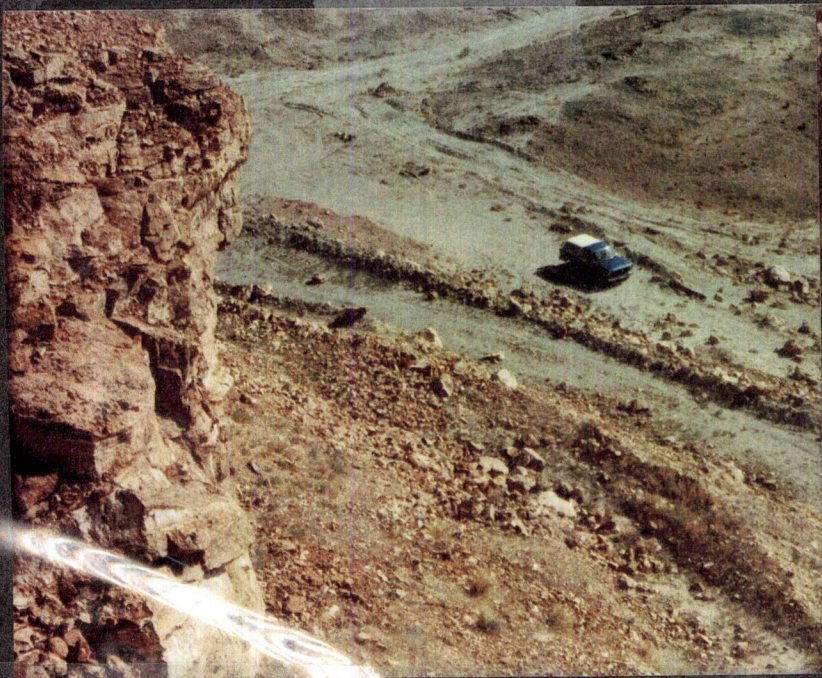
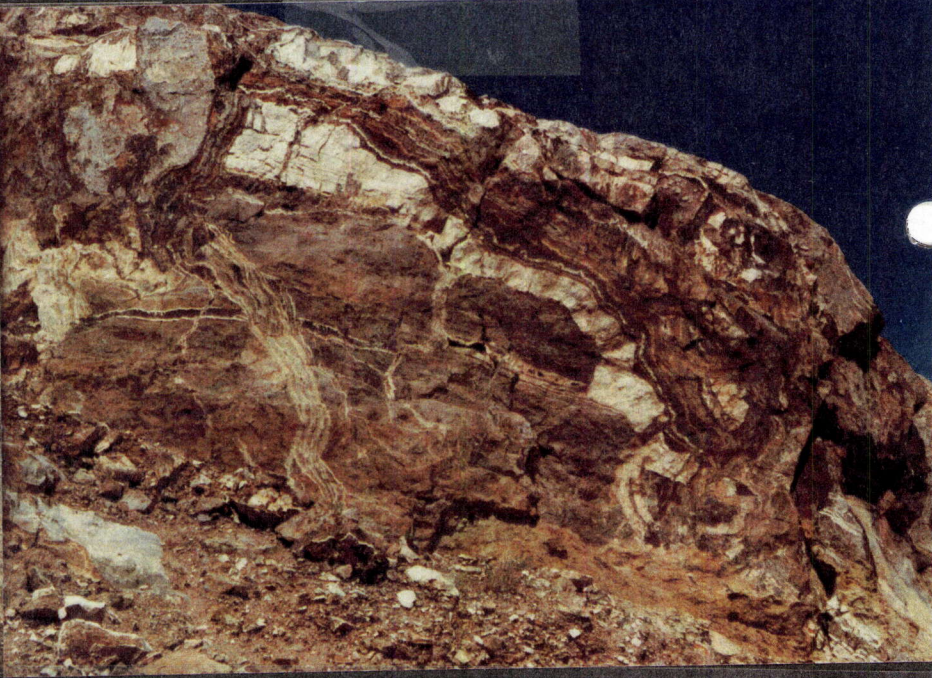
The travertine rock is being drilled and blasted off the side of a hill. There is a pile of loose rock at the foot of the hill and a series of small benches leading up the side of the hill. Total surface disturbance is less than two acres. It is doubtful if any reclamation work will ever be needed on this site because the broken rock on the side of the hill blends in well with the surrounding area.
